CARR - 689

606 UNIONTOWN ROAD

late 19th century

Westminster vicinity

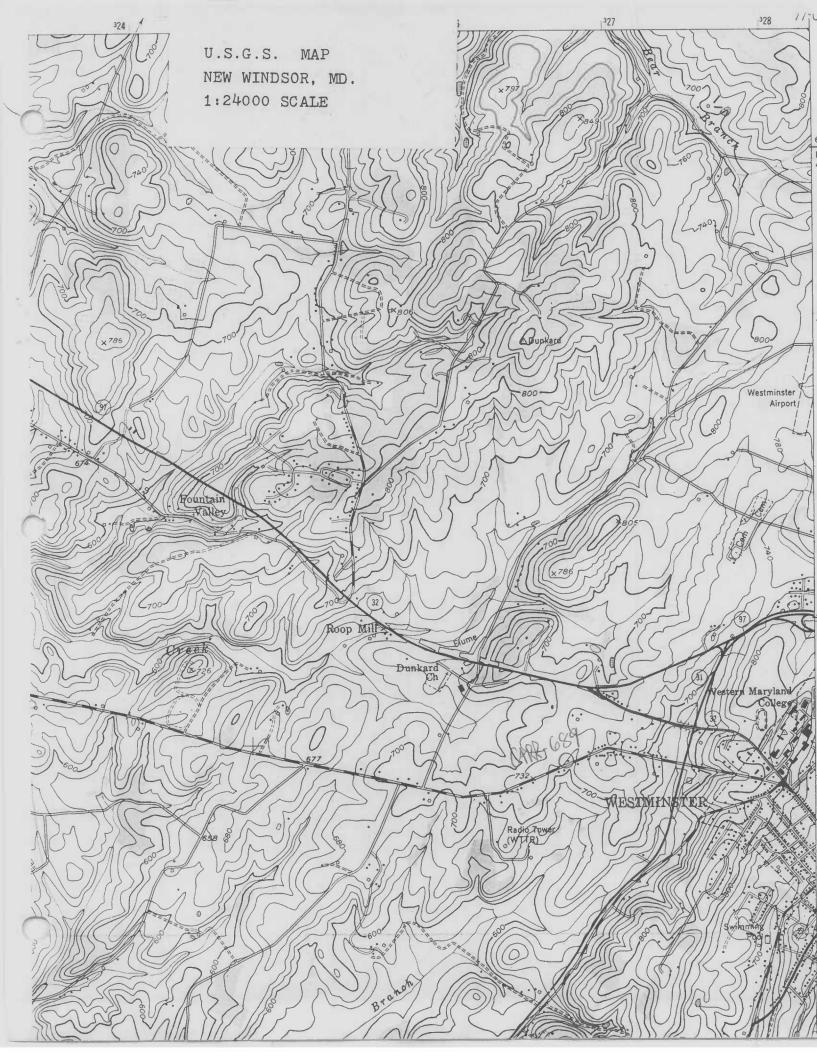
- 1. CARR-689 606 UNIONTOWN ROAD
- 2. Carroll County, Maryland
- 3. Joe Getty
- 4. August 1983
- 5. Md. Historical Trust, Annapolis, Md.
- South and east elevation (camera facing northwest)
- 7. 1/1
